What is Marlette Dam?

- Originally constructed in 1873 to provide water for the silver mining boom in Virginia City, Nevada
- Listed on the National Register of Historic Places
- Part of the Marlette Lake Water System, located 1 mile east of Lake Tahoe within Lake Tahoe Nevada State Park and within the Lake Tahoe Basin

Design

Key 60% Design Components

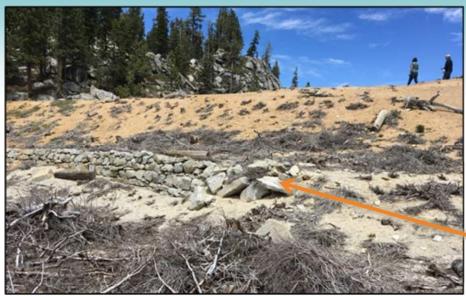
Existing Historic Wall

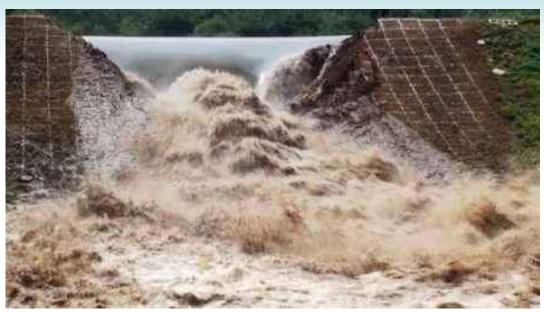
Risk of Catastrophic Failure

- Significant seepage through dam along primary outlet conduits
- Structural instability under seismic scenarios
- Emergency spillway undersized

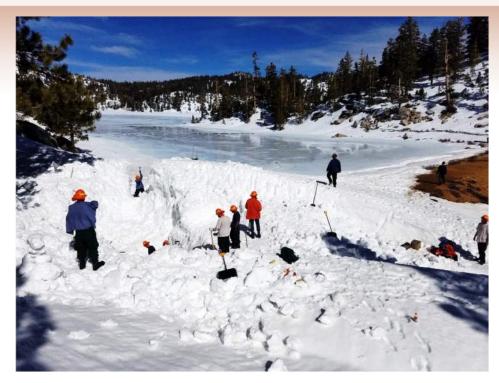
Emergency Spillway – March 14, 2017

Dam only accessible by helicopter/snowcat during winter

Outlet manually controlled by equipment that freezes

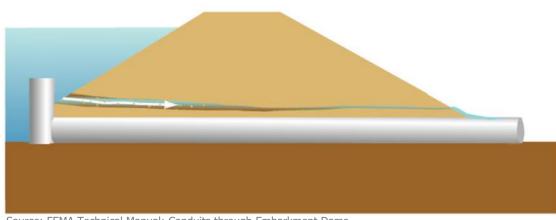
Source: FEMA Technical Manual: Conduits through Embarkment Dams

- Mitigate Seepage Along **Primary Outlets**
- 2. Reduce Emergency Outletting Risk
- 3. Stabilize Dam Embankment Structure

- Conduit Replacement Excavation
- Filter-Drain for Seepage Mitigation
 - Use of water stops no longer advised by FEMA
- Replace Emergency Spillway
- Raise Dam Crest 2.5± Feet
- Buttress Fill for slope stabilization
- Remote monitoring and control

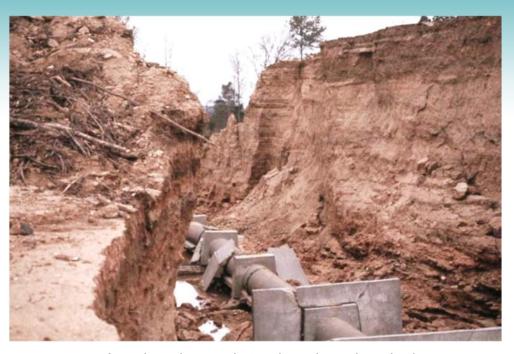
Source: FEMA's Technical Manual: Conduits through Embarkment Dams

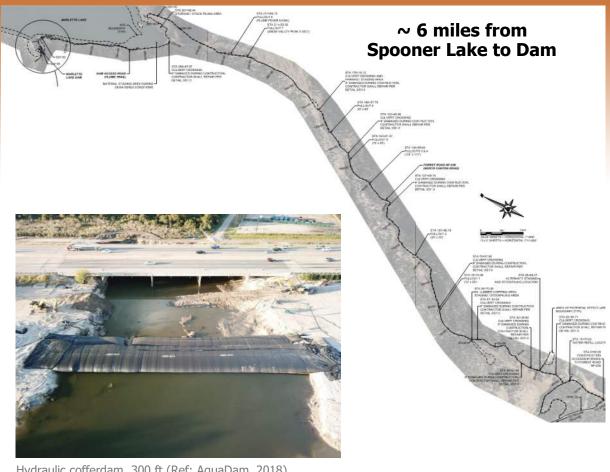
Hydraulic cofferdam, 300 ft (Ref: AquaDam, 2018)

- Dry construction → hydraulic cofferdam → dewater lake
- Steep slopes in tight canyons
- Stockpiling locations limited
